# OBERDORFER PUMPS

## Inspections for Possible Problems with Gear Pumps

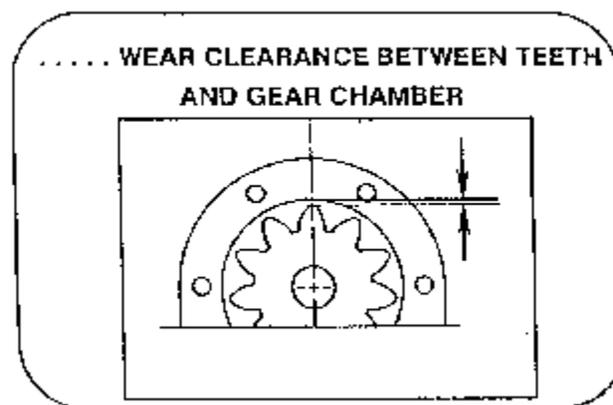
### Wear Clearance Between Gear Teeth and Gear Chamber:

A new pump would barely permit a sheet of wrapping paper to be inserted (.005 - .007 inches). Greater clearance is a result of wear or scrubbing of the teeth on the chamber wall. This means metal has been scrubbed off both the gear tips and the wall. When pumping, hydraulic and mechanical forces tend to separate the gears and force the gear tips against the walls. For the gears to shift to this wear position, the shaft bearings, normally holding gears in alignment, must also be worn. Check bearing wear.

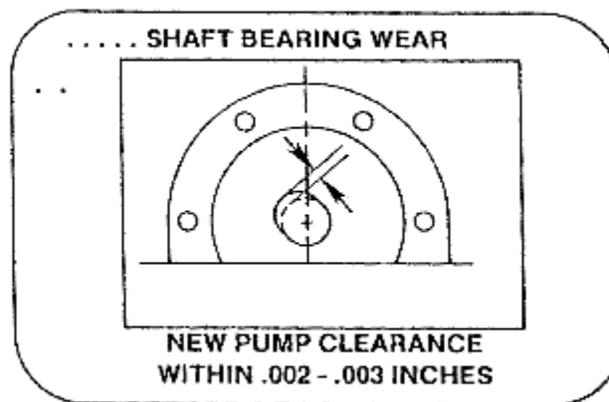
## Bearing Wear:

Check all bearings for wear. Since the idle shaft bearings are subjected to greater loads, they normally show greater wear. Severely worn bearings assume an egg shape. Some idea of bearing wear is obtained by removing the drive gear and shaft from the pump and re-inserting the exposed end of the shaft in each bearing as a plug gauge. (This is possible if the exposed shaft has not been damaged.) When a pump is new, clearance between the shaft and bearing is within .002 - .003 inches. This is the thickness of an average human hair. More clearance than this introduces the wear conditions described in the paragraph above. Severe wear between gear teeth and gear chamber, and bearing wear causes a pump to lose its ability to generate pressures and lift. Extreme noise and high power consumption are also symptoms. For gear tip wear, as described above, of .010 - .015 inches the pump would only have 30 - 40% of its pumping ability.

### Note Severe Wear Symptoms:

- Extreme Noise
- High Power Consumption
- Loss of Pressure
- Loss of Lift

**\* THIS PUMP SHOULD BE REPLACED, IT IS BEYOND REPAIR.**

It is time to replace the pump!

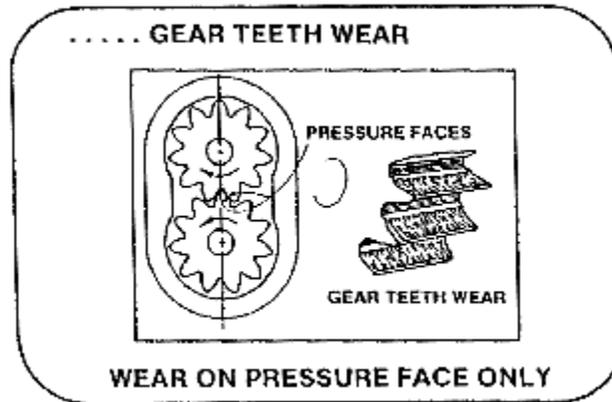
## Gear Wear:

Gear teeth wear occurs on the pressure face of each tooth only. The extent of wear can be approximated by visualizing the tooth profile on the back face transposed to the pressure face. Wear can cause noise, loss of pumping, priming, or lift ability.

**THIS PUMP SHOULD BE REPLACED – IT IS BEYOND REPAIR.**

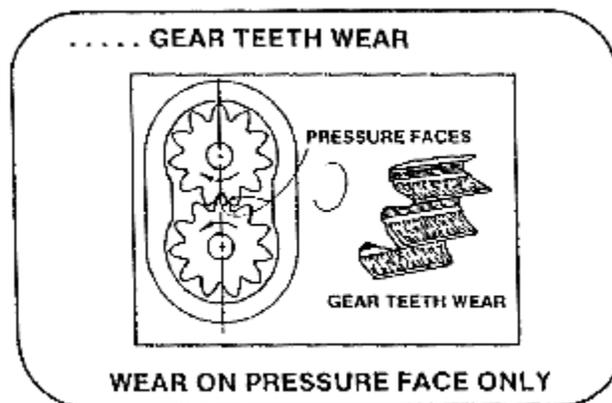
A second form of gear wear is on the gear side faces (thickness). It is extremely critical to pump performance (lift and pressure ability). Wear is observed by noting the level of the gear face below the flange surface. For a new pump, the gear face is even with or slightly above (.001 inches) the body flange. If the gear face falls below the flange by as little as the thickness of a sheet of wrapping paper (.005 - .007 inches) the pump will have only about 30-40% of its original ability to generate pressure and lift.

**THIS PUMP SHOULD BE REPLACED – IT IS BEYOND REPAIR.**

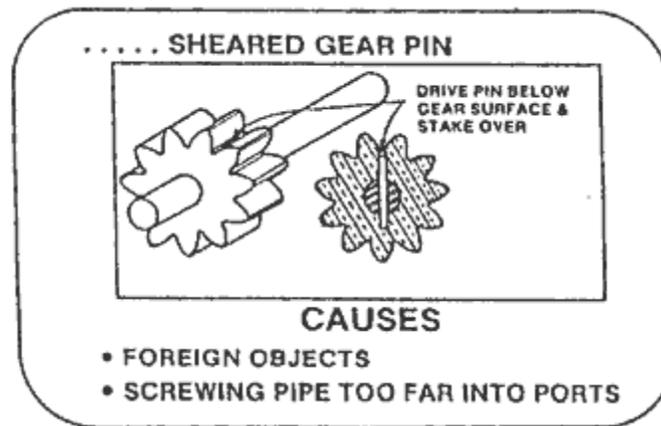
Shared Pin:

On all gear pumps, the drive gear is pinned to the shaft. The shaft of a pump with a sheared pin can be rotated but will have absolutely no pumping ability, since the gears are not turning. If the pin is sheared due to a foreign object entering the pump and jamming the gears, or by screwing the pipes too far into the ports to jam the gears, repair can be made by redrilling and driving a rod into the hole(s). Use size and number of pins as evident on damaged parts. Since bronze is a soft metal, care must be exercised when placing parts in a vice – lead or wooden vice jaw protectors should be used.

Be sure to stake over the hole to prevent the pins from working out when in operation. Check the gears for ability to mesh with each other and remove burrs or other damage with a fine file as necessary.

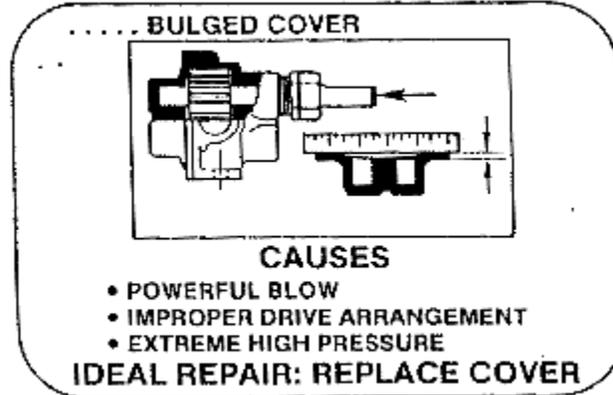
## **Bulged Cover:**

A powerful blow or force on the exposed pump shaft can cause the bulged pump cover. Another cause for a bulged cover is an improper drive arrangement where excessive shaft thrust is exerted by the drive mechanism. This would also show wear on the cover and gear face. Extremely high pressure due to accidentally shutting off the pump discharge line, and where no pressure relief equipment existed, could also cause a bulged cover. Place a straight edge across the cover face and check for bowing. The clearance caused by a bulged cover permits by-pass and slippage. If the clearance is appreciable, the pump has little ability to lift and generate pressures. Emergency repair can be made by grinding or sanding the cover flat. Ideal repair is to replace the cover. When this type of damage is evident, inspect the drive gear for gear teeth damage and for a sheared pin described above.
