| ASSEMBLY TYPE: TCPSSMAX | ITEM CODE: N/A | ASSEMBLY | |
| DESCRIPTION: TCPSSMAX-CI (115/230V) | | HANDING: N/A | Sheet 1 of 2 |

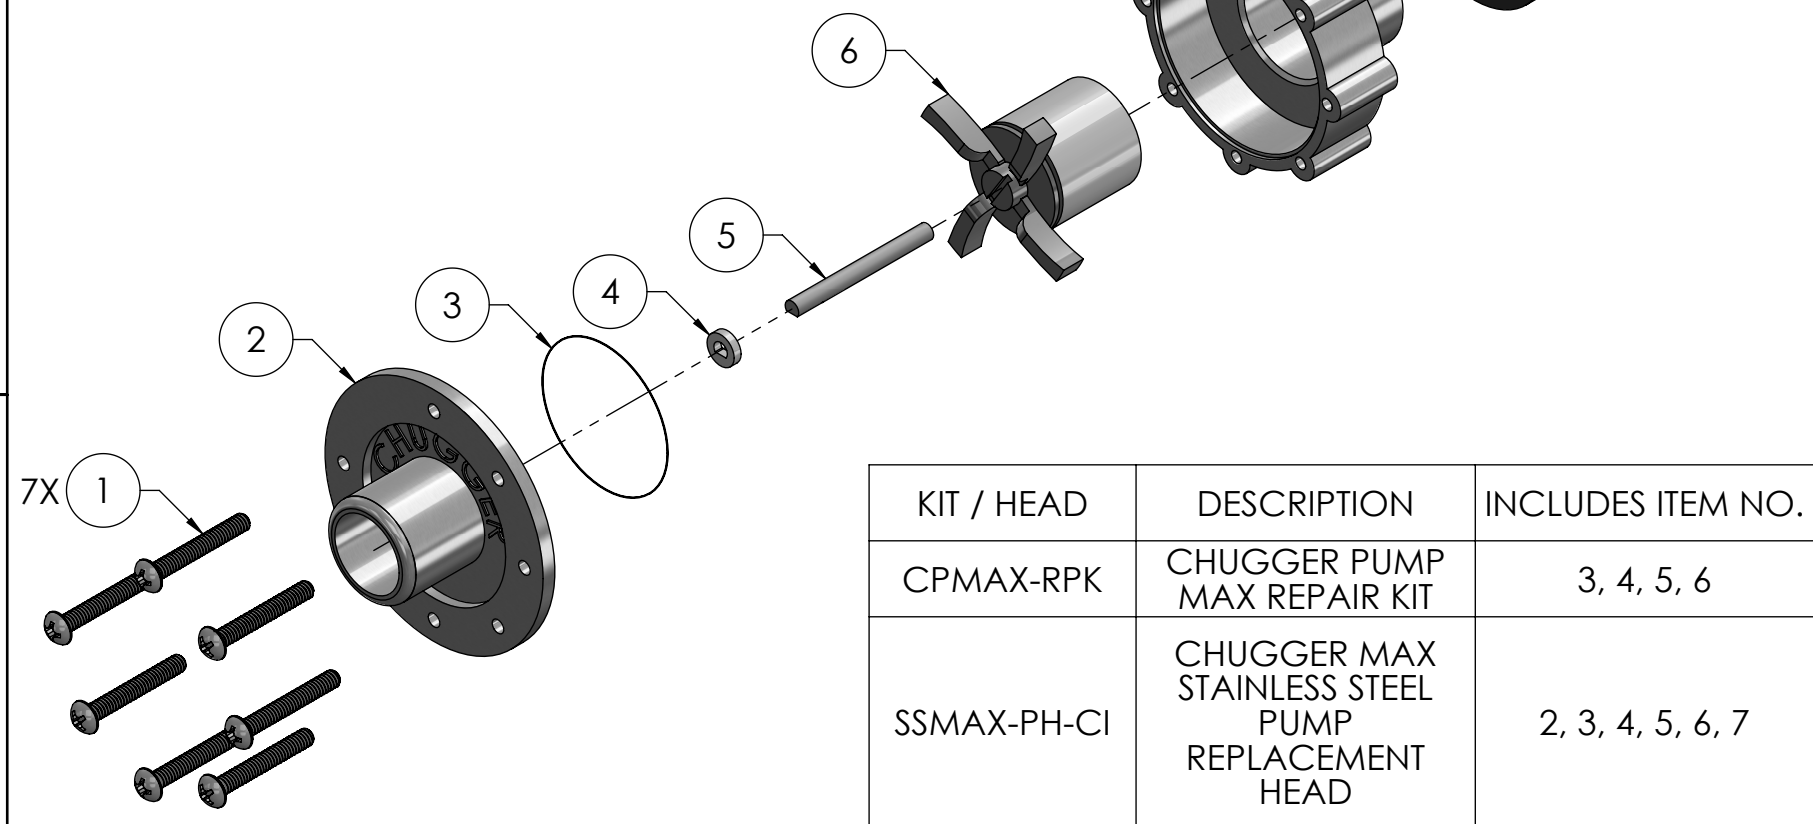
4X (11)
4X (12)

| ITEM NO. | PART NUMBER | DESCRIPTION | QTY. |
| 1 | CPMAX-21 | SCREW, SS, 4 x 45 mm | 7 |
| 2 | SSMAX-PH-CI | FRONT COVER, STAINLESS STEEL | 1 |
| 3 | CPMAX-23 | O-RING, SILICONE, 77 x 1.8 mm | 1 |
| 4 | CPMAX-24-2 | THRUST WASHER, CERAMIC | 1 |
| 5 | CPMAX-24-1 | SHAFT, 316 SS, 63.7 x 6.33 mm | 1 |
| 6 | CPMAX-25 | IMPELLER, PSS + TFE, SS, 40 x 48 mm | 1 |
| 7 | SSMAX-PH-CI | REAR HOUSING, STAINLESS STEEL | 1 |
| 8 | CPMAX-27 | MAGNET, REINFORCED PA66 | 1 |
| 9 | CPMAX-28 | BRACKET, REINFORCED PA66 | 1 |
| 10 | NOT SOLD INDIVIDUALLY | TEFC MOTOR | 1 |
| 11 | N/A | WASHER, 1/4" | 4 |
| 12 | N/A | REAR HOUSING BOLT | 4 |
