| ASSEMBLY TYPE:<br>TCPSPMAX | ITEM CODE:<br>N/A | <b>ASSEMBLY</b> | |
| DESCRIPTION:<br>TCPSPMAX-CI (115/230V) | | HANDING:<br>N/A | Sheet 1 of 2 |

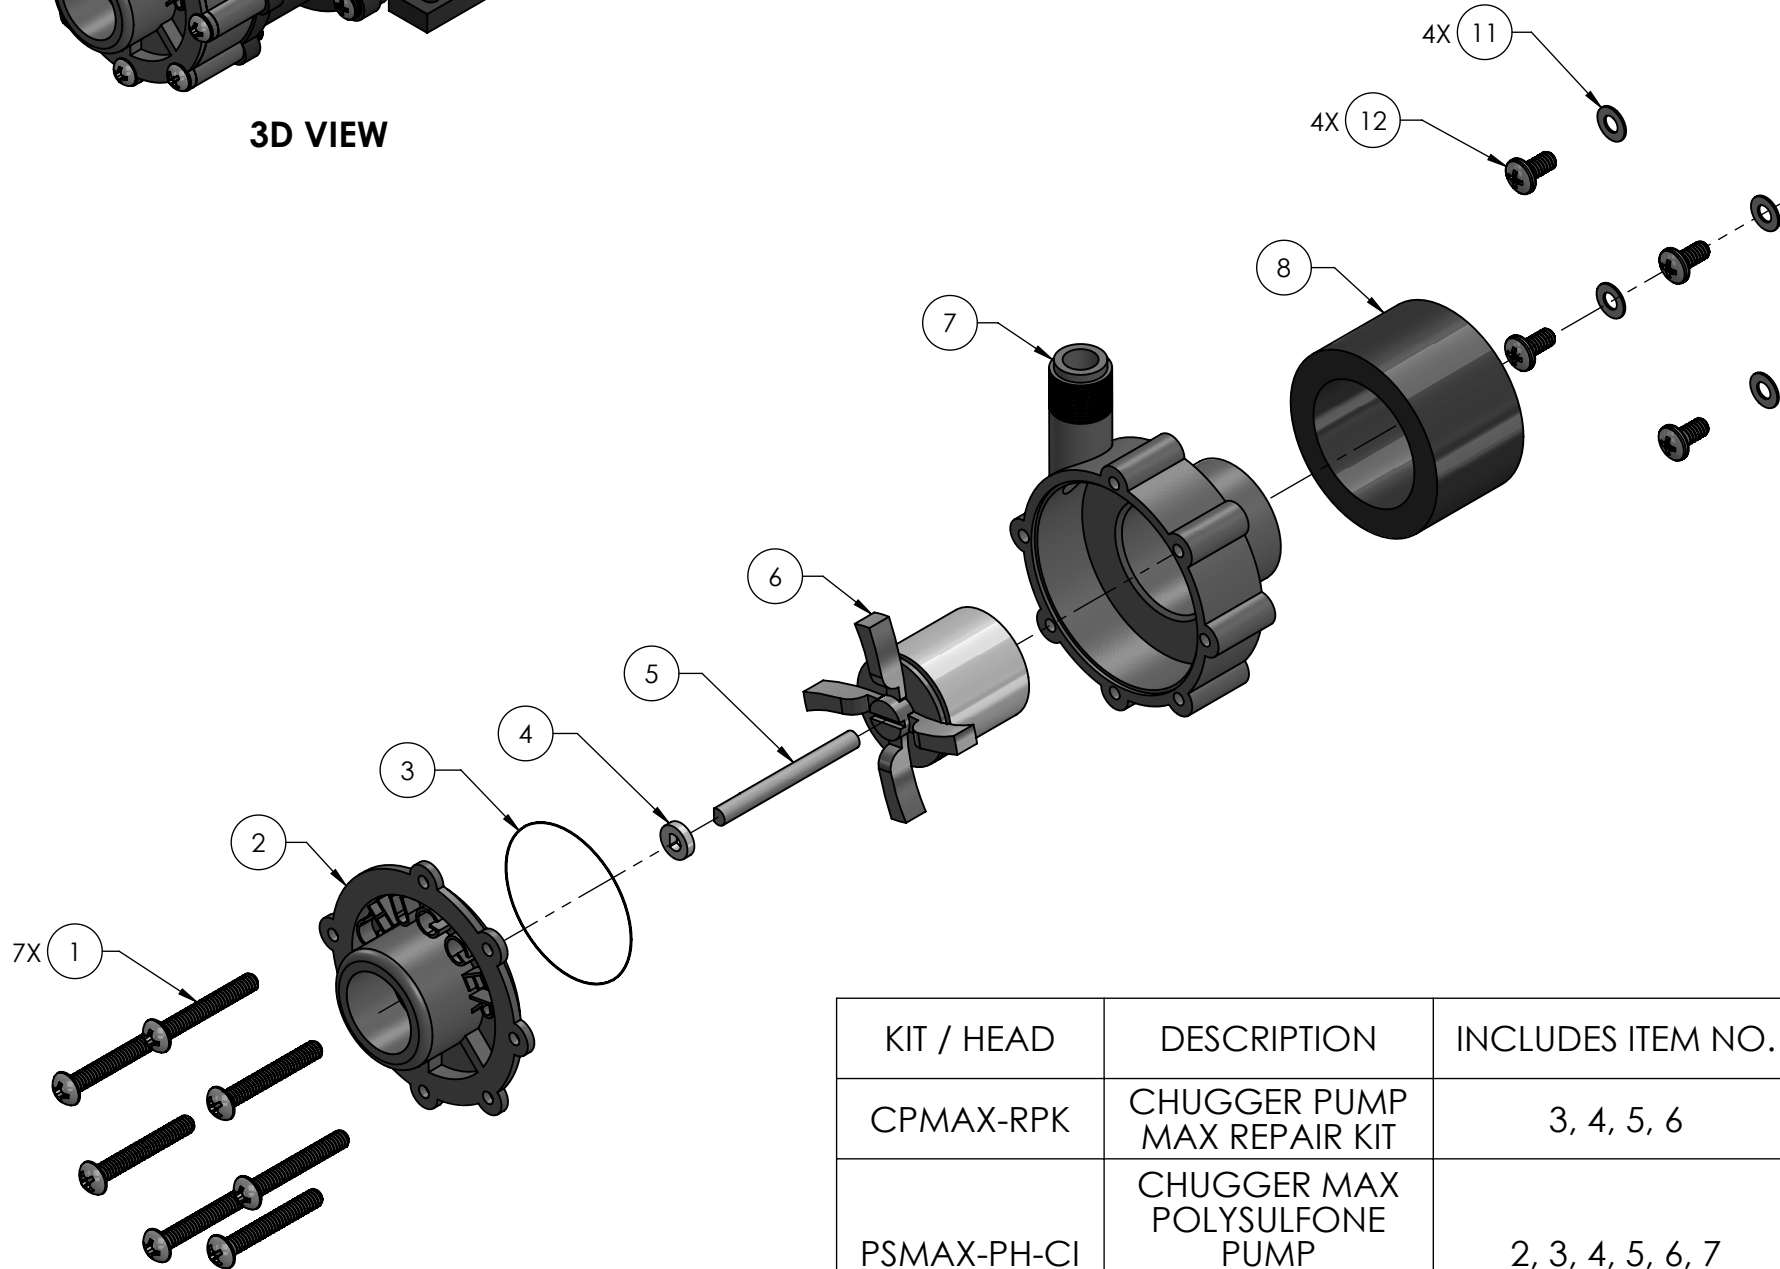
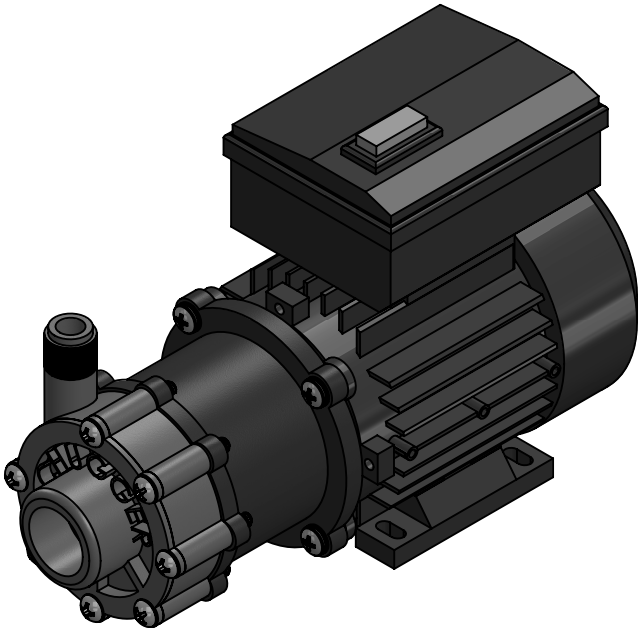
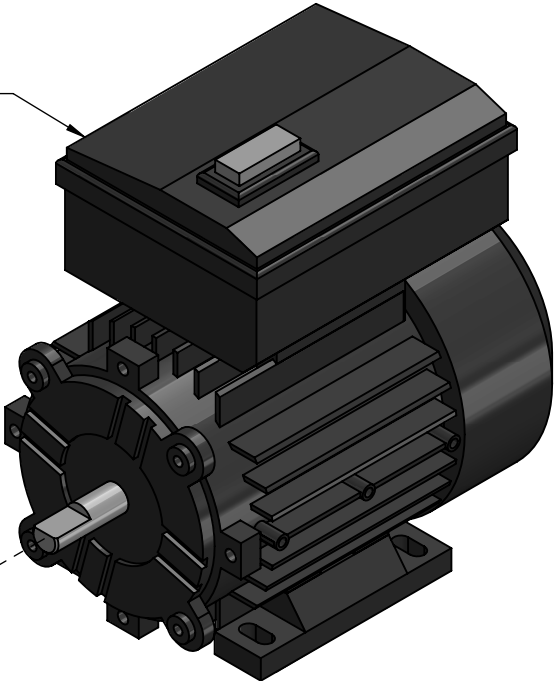
3D VIEW

| ITEM NO. | PART NUMBER | DESCRIPTION | QTY. |
| 1 | CPMAX-21 | SCREW, SS, 4 x 45 mm | 7 |
| 2 | PSMAX-PH-CI | FRONT COVER, POLYSULFONE | 1 |
| 3 | CPMAX-23 | O-RING, SILICONE, 77 x 1.8 mm | 1 |
| 4 | CPMAX-24-2 | THRUST WASHER, CERAMIC | 1 |
| 5 | CPMAX-24-1 | SHAFT, 316 SS, 63.7 x 6.33 mm | 1 |
| 6 | CPMAX-25 | IMPELLER, PSS + TFE, SS, 40 x 48 mm | 1 |
| 7 | PSMAX-PH-CI | REAR HOUSING, POLYSULFONE | 1 |
| 8 | CPMAX-27 | MAGNET, REINFORCED PA66 | 1 |
| 9 | CPMAX-28 | BRACKET, REINFORCED PA66 | 1 |
| 10 | NOT SOLD INDIVIDUALLY | TEFC MOTOR | 1 |
| 11 | N/A | WASHER, 1/4" | 4 |
| 12 | N/A | REAR HOUSING BOLT | 4 |
